**REPORT ON THE MANAGEMENT  
OPERATION AND MAINTENANCE  
OF THE MACON WATER AUTHORITY'S  
SEWER CONVEYANCE SYSTEM**

**JANUARY 1, 2004 THRU DECEMBER 31, 2004**

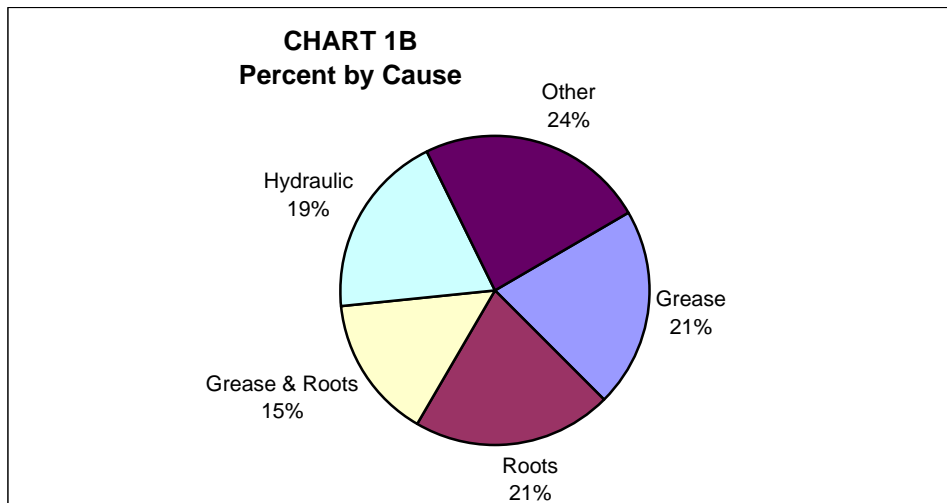
## Appendix II - 1: Analysis by Cause

Cause	# Spills	% of Total
Grease	14	20.9%
Roots	14	20.9%
Grease & Roots	10	14.9%
Hydraulic	13	19.4%
Other	16	23.9%

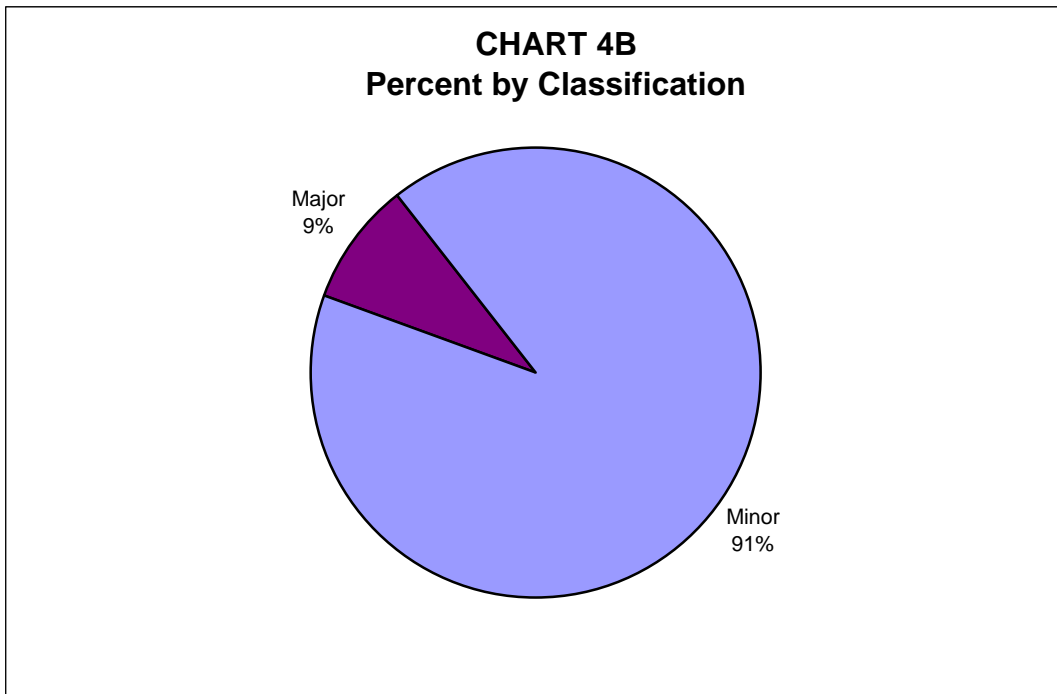
## Appendix II - 4: Analysis by Classification

Classification	# of Spills	% Total
Major	6	9.0%
Minor	61	91.0%

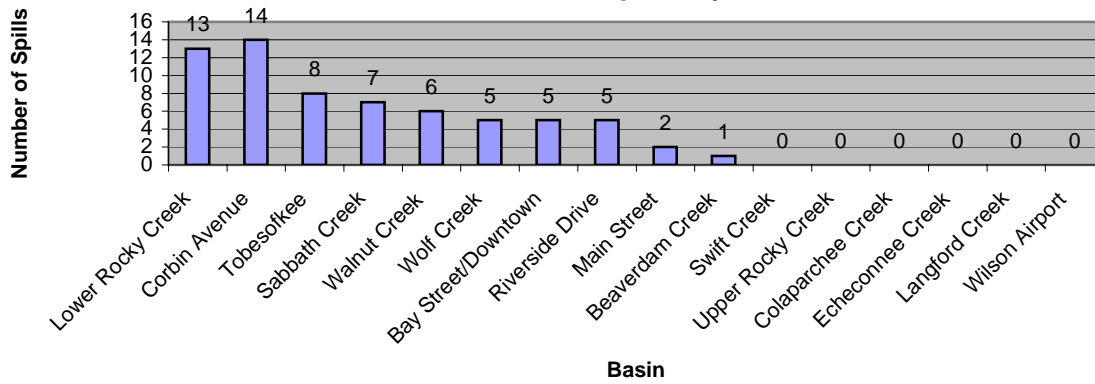
### CHART 6A Number Of Spills By Basin

Basin	# Spills	% of Total
Lower Rocky Creek	13	19.7%
Corbin Avenue	14	21.2%
Tobesofkee	8	12.1%
Sabbath Creek	7	10.6%
Walnut Creek	6	9.1%
Wolf Creek	5	7.6%
Bay Street/Downtown	5	7.6%
Riverside Drive	5	7.6%
Main Street	2	3.0%
Beaverdam Creek	1	1.5%
Swift Creek	0	0.0%
Upper Rocky Creek	0	0.0%
Colaparchee Creek	0	0.0%
Echeconnee Creek	0	0.0%
Langford Creek	0	0.0%
Wilson Airport	0	0.0%

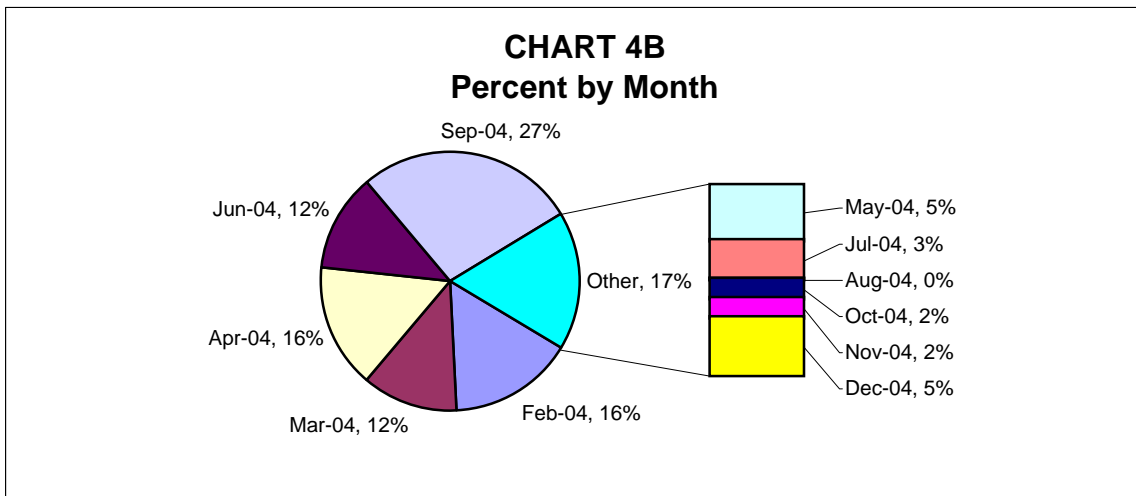
**DATA TABLE**

Month	# Spills	% of Total
Jan-04	9	13.4%
Feb-04	9	13.4%
Mar-04	7	10.4%
Apr-04	9	13.4%
May-04	3	4.5%
Jun-04	7	10.4%
Jul-04	2	3.0%
Aug-04	0	0.0%
Sep-04	16	23.9%
Oct-04	1	1.5%
Nov-04	1	1.5%
Dec-04	3	4.5%
